SCOUR PROTECTION FOR PIKE ISLAND DAM, OHIO RIVER

Hydraulic Model Investigation

Final Report

Prepared for US Army Engineer District, Pittsburgh
Pittsburgh, Pennsylvania 15222-4186

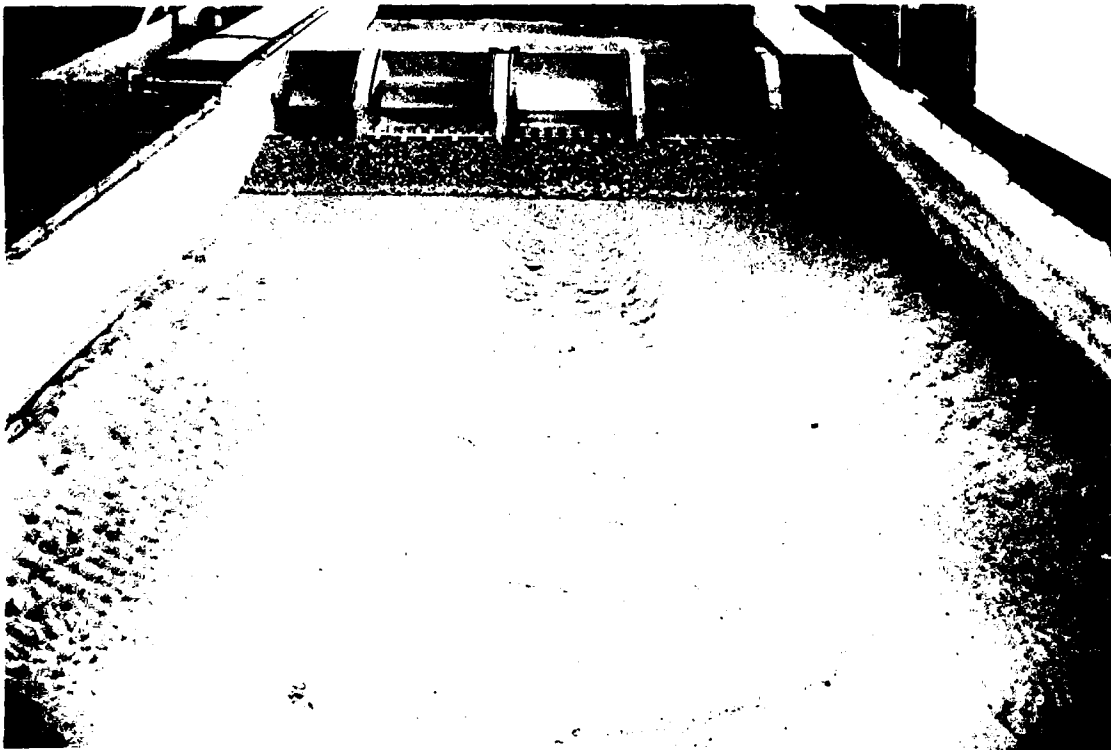
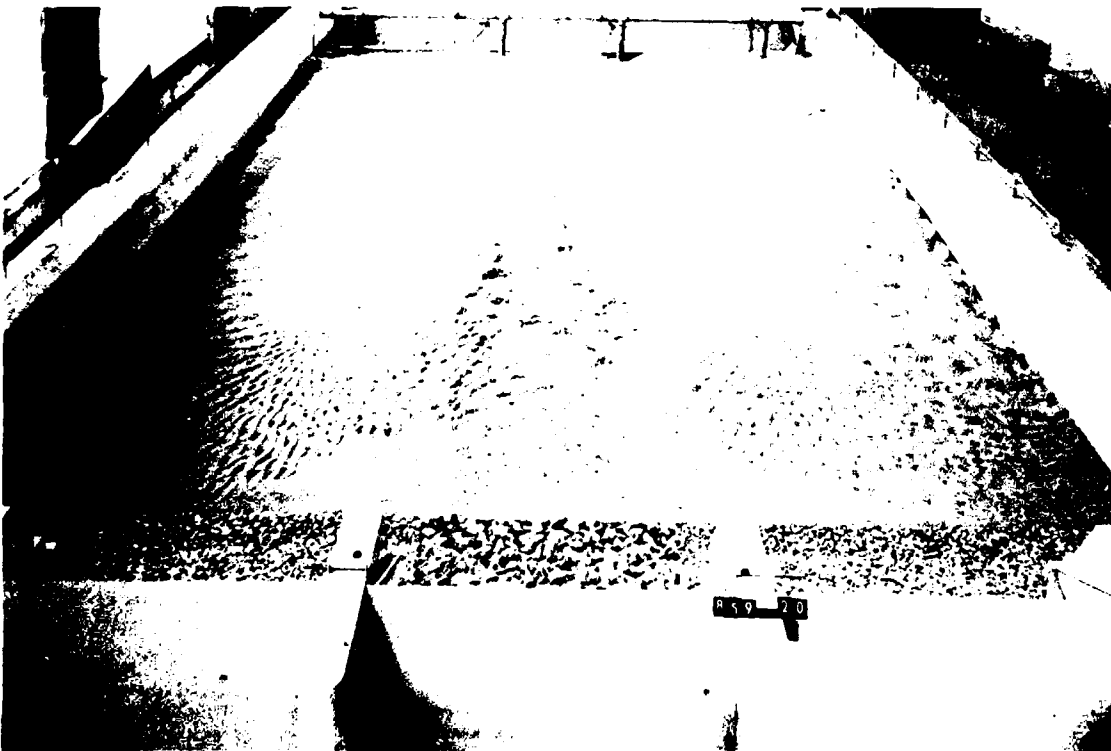
16. Flow conditions with the minimum tailwater elevation (634) where the type 2 riprap plan remained stable with uncontrolled flow through one gate bay are shown in Photo 4. Photographs of the scour in the exit channel after 5 hours (prototype) of operation with these conditions are shown in Photo 5 and a center-line scour profile is shown in Plate 17. Although the type 2 riprap plan was considered stable with uncontrolled flow and a tailwater elevation of 634, this operation should be avoided, if possible, due to the extreme amount of turbulence observed. Uncontrolled flow with a normal tailwater, el 643.3, is shown in Photo 6 for comparison of turbulence with the two flow conditions.

Photo 5. View of scour in exit channel after 5 hr of operation
with pool el 644, tailwater el 634, and uncontrolled flow

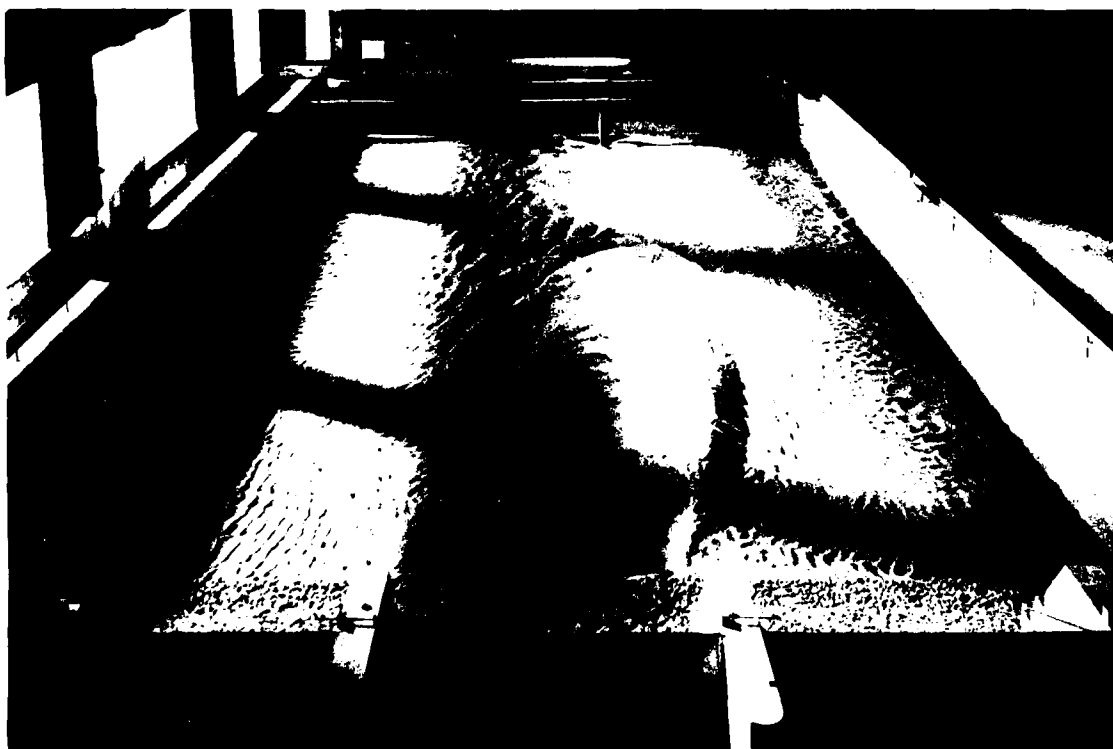
17. Previous model studies have shown that severe scour and occasionally failure of the riprap blanket occur with an undulating jet exiting the stilling basin. This flow condition occurs for large gate openings with high tailwater. The most severe condition where an undulating jet formed with the submergible gate and stilling basin for the Pike Island model was a 14-ft gate opening and tailwater elevation of 636.0. Photographs of scour in the exit channel after 5 hours (prototype) of operation with the undulating jet flow condition, are shown in Photo 7 and a center-line scour profile is shown in Plate 18. Considerable scour occurred in the exit channel, but the type 2 riprap plan was stable because the stones located on the upper portion of the blanket were not displaced. Displacement at the toe occurred due to undermining of the stone, and sufficient toe protection should eliminate this.

Photo 7. Scour in exit channel after 5 hr of operation with pool el 644, tailwater el 636.0 and a 14-ft gate opening

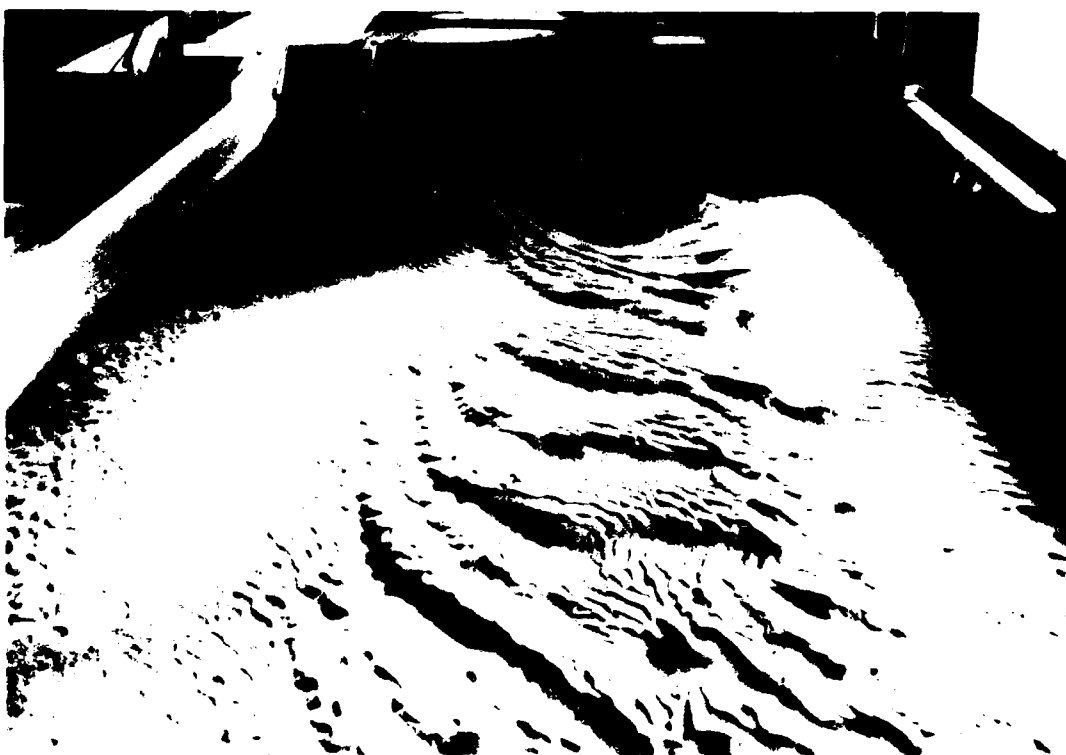
Photo 10. View of scour in exit channel after 5 hr of operation, with pool el 644, tailwater el 636, and a 14-ft gate opening, and the type 2 riprap placed horizontally

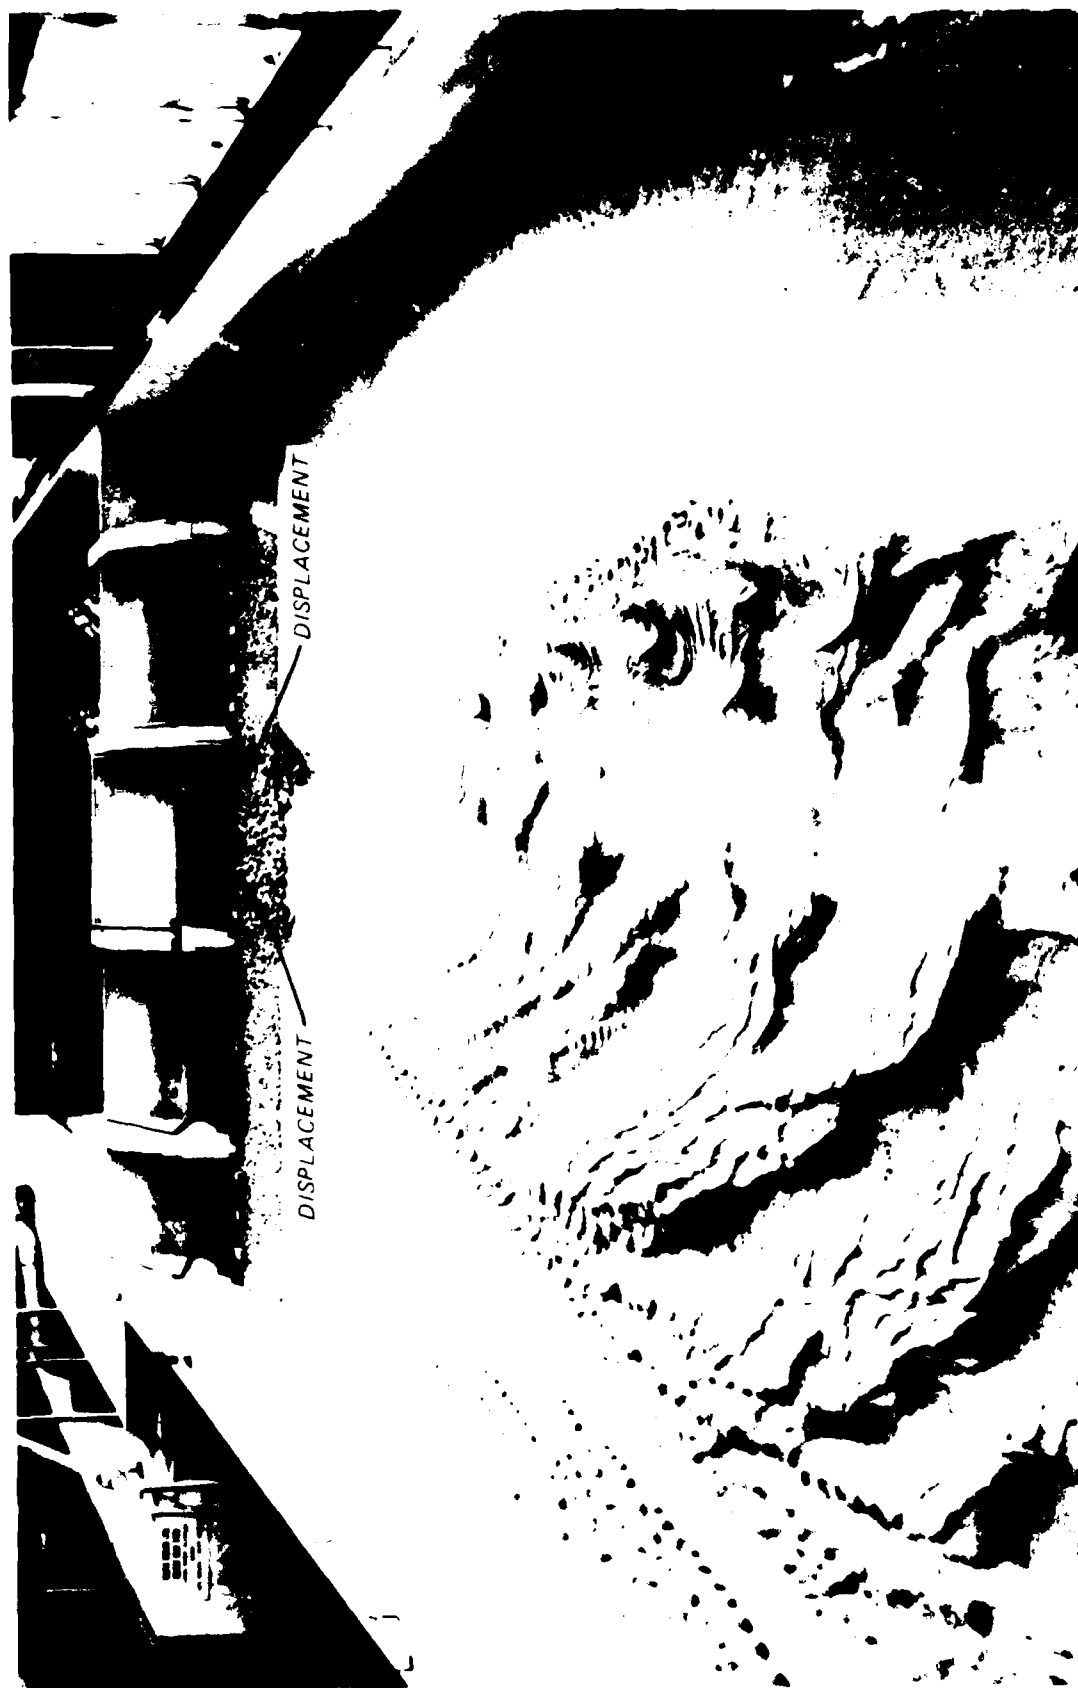
Photo 11. View of scour in exit channel after 5 hr of operation with pool el 644, tailwater el 623, and an 8-ft gate opening and the type 2 riprap placed horizontally

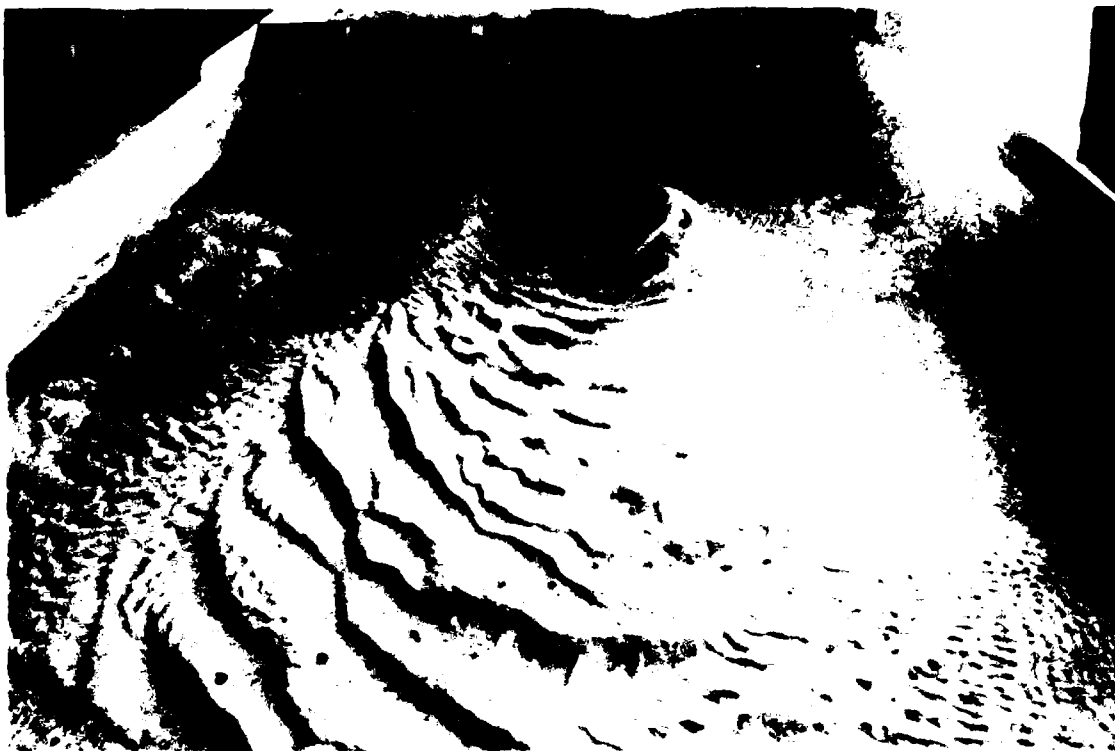
filled with grout was placed downstream of the bulkhead pad. There was concern that this addition might change flow conditions enough to effect the stability of the riprap on the sloped portion of the protection. Also, the riprap in this design had a maximum diameter of 5 ft instead of 6 ft which was equivalent to reducing the weight from 18,662 lbs to 10,800 lbs. All stones previously used for the type 2 riprap that had equivalent weights more than 10,800 lbs were replaced. A test was conducted for 5 hours (prototype) with normal upper pool, an 8-ft gate opening, and a tailwater elevation of 623, and the design remained stable. Another test was conducted for 5 hours (prototype) with normal upper pool, 14-ft gate opening and a tailwater el of 636. Photographs of the scour in the exit channel after the completion of this test are shown in Photo 12. The photograph illustrates the scouring potential of this type flow, but the riprap remained stable. Displacement at the toe occurred due to undermining of the stone, and sufficient toe protection would eliminate this. This design was considered stable for all flow conditions where the type 2 riprap placed on a 1V on 3H slope remained stable.

Photo 12. View of scour in exit channel after 5 hr of operation,
with pool el 644, tailwater el 636, a 14-ft gate opening
and the recommended plan

26. The final design tested, Plate 24, consisted of a short section of tremie concrete and a row of grout-filled fabric bags placed horizontally just downstream of the stilling basin followed with 5-ft-diameter stones placed on a 1V on 3H slope. This plan was stable for the same flows where the type 2 riprap plan placed on a 1V on 3H downward slope remained stable. These conditions are indicated on the stability curve shown in Plate 5. Therefore, this design is recommended to protect the area immediately downstream from the Pike Island Dam stilling basin. The plan provides good granular filters underneath the 5-ft-diameter stones and has additional stone protection at the toe. This plan should not be subjected to conditions indicated as unstable for the type 2 riprap plan (4- to 6-ft-diameter stones placed on a 1V on 3H downward slope) shown in Plate 5. It is also recommended that the area to be repaired be excavated or filled as necessary so that the 5-ft-diameter stones can be placed on a 1V on 3H downward slope. Turbulent flow conditions exist below the stilling basin for gate openings equal to and greater than 8 ft with minimum tailwater. It was beyond the scope of this model study to develop a scour protection plan that could withstand uncontrolled flow and minimum tailwater. It is extremely important that 8- and 10-ft gate openings with a tailwater elevation of 623 be operated for as short a period as possible, and gate openings greater than 10 ft with minimum tailwater never be allowed.

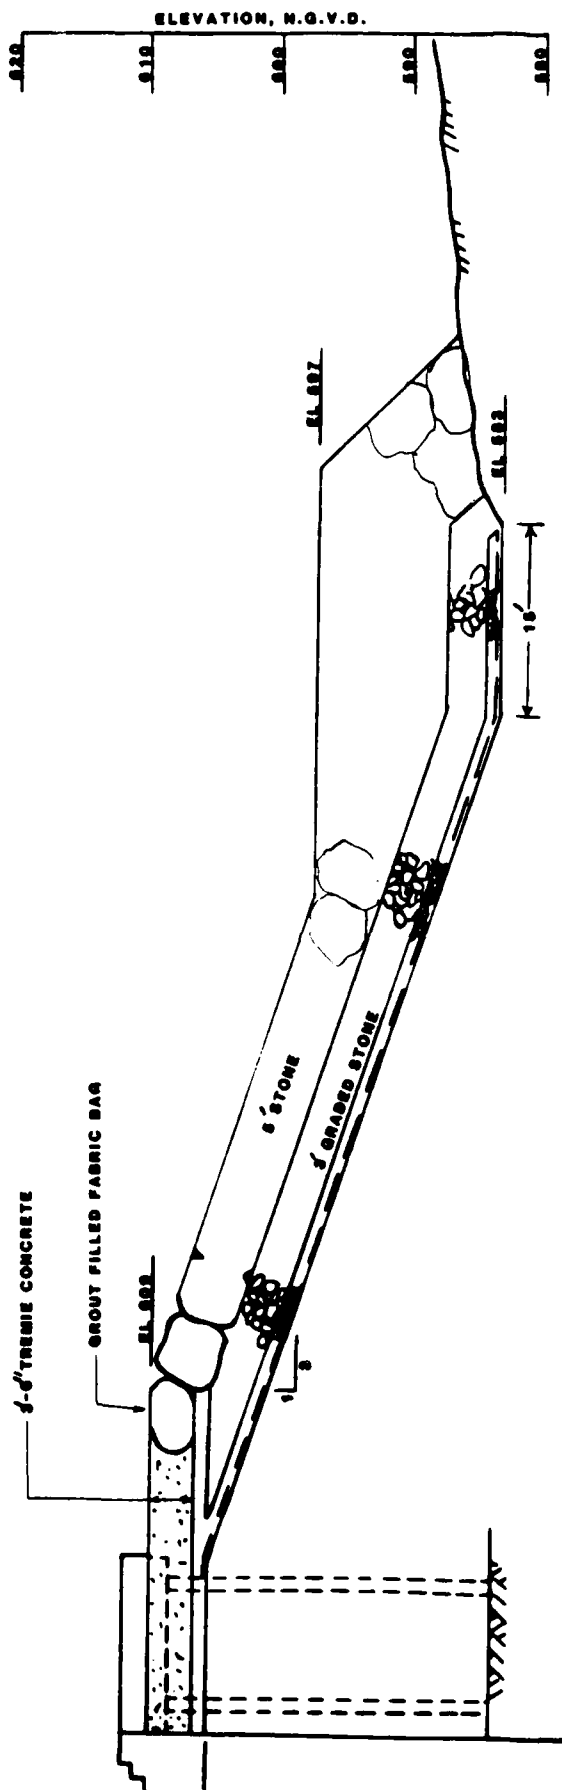
RECOMMENDED PLAN

24. The scour protection plan shown in Plate 24 was designed by the ORP to repair the scoured area immediately below the stilling basin. This design was placed in the model and tested to insure the adequacy of the plan. The design differed slightly from the type 2 riprap placed on a 1V on 3H slope in that an additional 14-ft horizontal section of tremie concrete and fabric bag
